CONDITION ASSESSMENT OF EXISTING BRIDGE STRUCTURES

**GTRC Project No. E-20-K90
GDOT Project No. RP05-01**

REPORT OF TASKS 2 AND 3 – BRIDGE TESTING PROGRAM

**GEORGIA INSTITUTE OF TECHNOLOGY
SCHOOL OF CIVIL & ENVIRONMENTAL ENGINEERING**

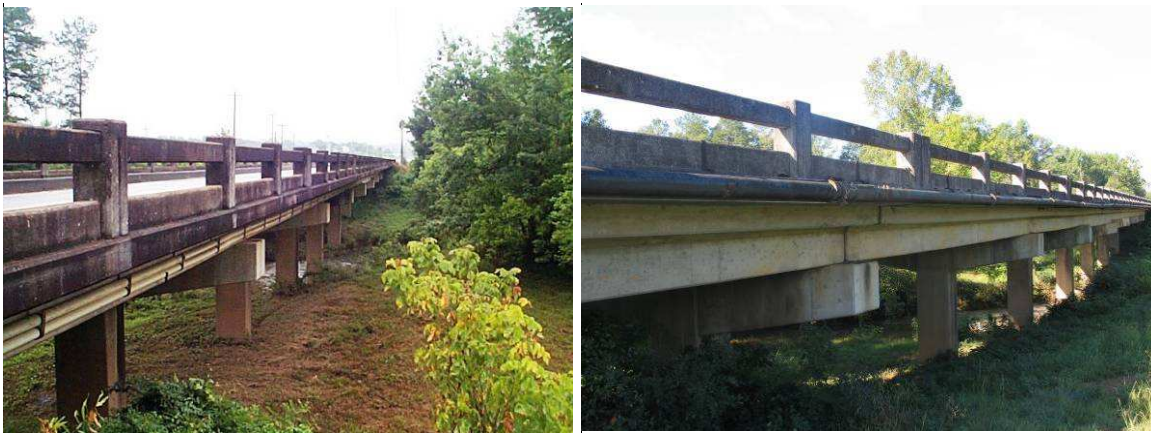
This bridge is a reinforced concrete T-Beam structure, which is located in Gordon County GA, and carries State Route 156 over Oothkalooga Creek approximately 1 mile west of Calhoun, GA. It was designed according to the AASHTO 1953 *Design Specification* for H-15 traffic load, constructed in 1957, and is not posted. The centerline of the bridge is unskewed with respect to the girder supports. Figure 3.1 shows an overview of the girder and bridge structure, while Figure 3.2 presents a schematic labeling each of the bridge's spans and bents.

Figure 3.1 Bridge 129-0045-0 Overview

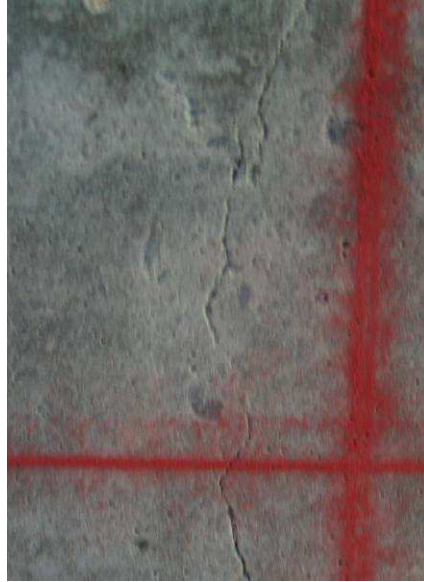
instrumentation, only minor hairline cracking in the girders was noted, as reported in the GDOT inspection report. However, after grinding and cleaning the girder surfaces for the purpose of instrumentation, flexural cracking at mid-span was clearly visible (Figure 3.6).

Figure 3.6 Flexural Crack in Girder

According to the GDOT bridge inspector's report, the deck has undergone moderate surface deterioration, scaling, and cracking and has been patched multiple times. The inspector did not identify the location or size of specific cracks or patches; however, upon visiting the structure, the patches were easily distinguishable from the underside of the bridge. In most cases, plywood still covered the underside of the patch, and where the plywood had been removed, the outline of each patch was visible. The bridge deck was given a condition assessment rating of 5 (cf Table 1.1) by the GDOT inspector. The supporting reinforced concrete girders were less deteriorated and the inspector gave them a condition rating of 7. Upon initial inspection, while preparing the girders for

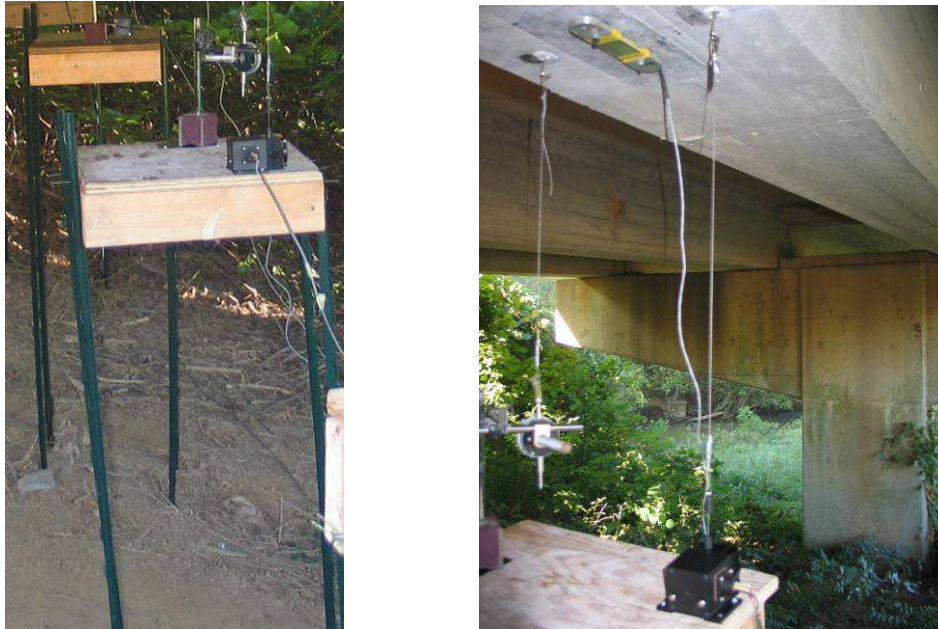
It was decided to compare the global performance of the bridge to that of the FE analysis through measuring the deflection of the girders. Accordingly, the instrumentation of the bridge consisted of both potentiometers and mechanical dial gauges, used for redundancy, (Figure 3.7 and 3.8). The gauges were all supported by stable elevated platforms and a cable was hung from the bottom of each girder down to the platform below using hooks epoxied into place (Figure 3.9).

Figure 3.9 Mounting Base (Left), Cable Connecting Gauges to Girders (Right)

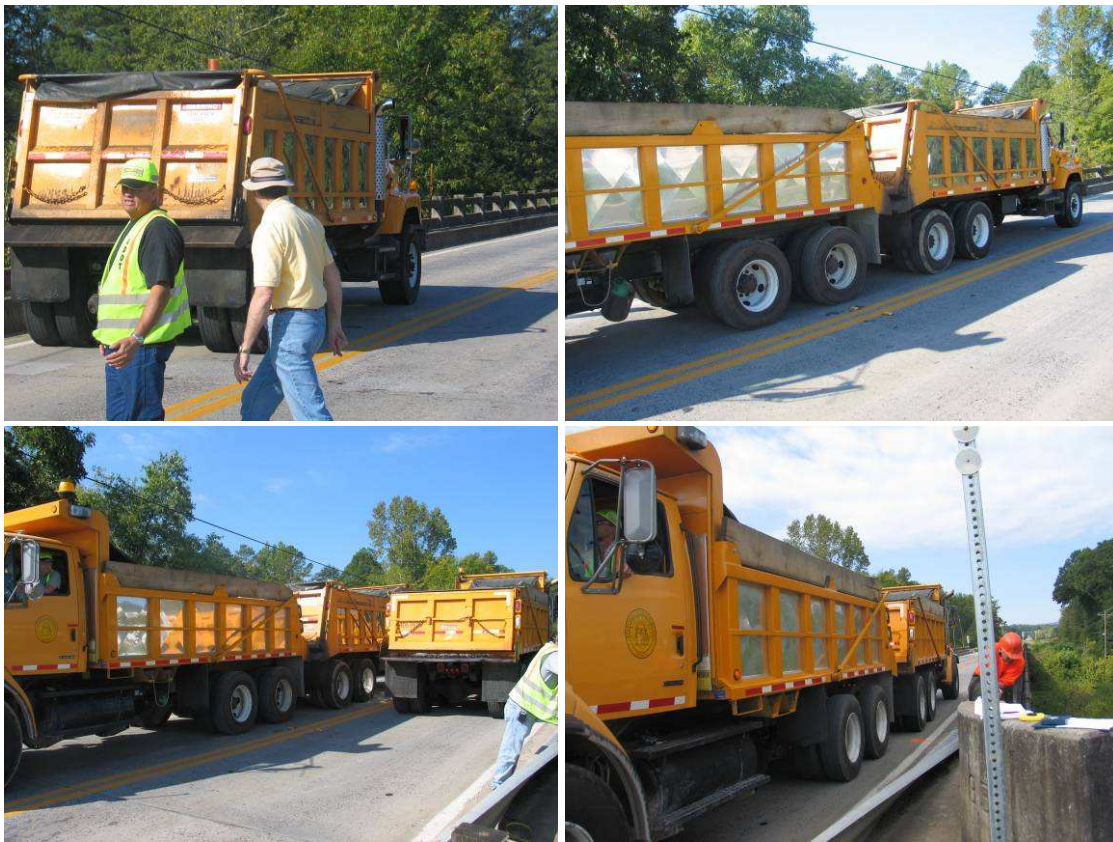
**Figure 3.14 1 truck (top left), 2 trucks (top right),
3 trucks (bottom left), 4 trucks (bottom right)**

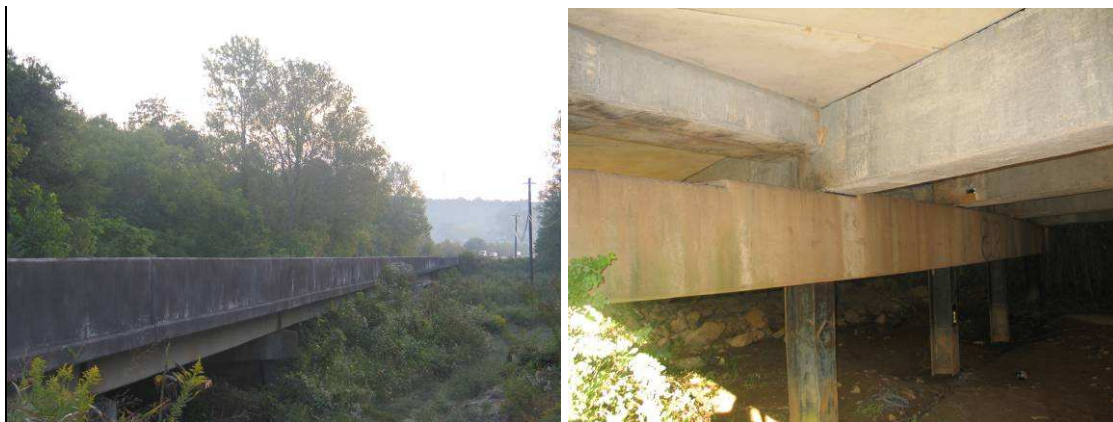
Bridge 015-0108-0 is located in Bartow County GA, and carries Old Alabama road over Pumpkinvine Creek approximately 3.7 miles west of Cartersville, GA. Figure 4.1 shows an overview of the bridge and its girder and slab structure.

Figure 4.1 Bridge 015-0108-0 Overview

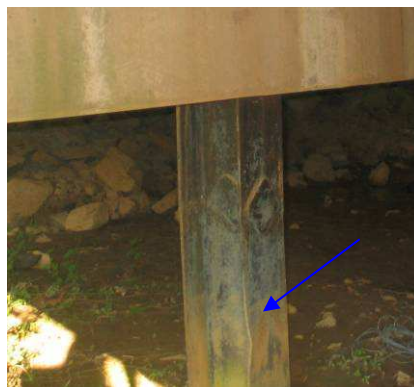
The GDOT inspector found minor cracking and spalling in a number of the bents and abutments, but judged that none of them required repair. He also reported that the steel piles of bent 6 along one of the creek embankments needed cleaning, painting, concrete encasement, and sway bracing, and that the embankment needed to be reinforced with rip-rap to prevent continued scour. During instrumentation, the concrete pier caps showed no significant deterioration, but the piles showed sign of flange local buckling (Figure 4.8) approximately at mid-height between the ground and pier cap in the affected piles. The most prominent buckling was found in the piles along the creek bank (bent 6). The piles along the creek banks have unsupported lengths as long as 15 ft (4.6 m) while the piles over the flood plain have unsupported lengths of only 5 ft (1.52 m). All of the piles are H12x53 piles and their buckling load capacity, taken from AISC 13th Ed., is 488 kips (2171 kN), based on an unbraced length of 5 ft (1.52 m), and $b_f / 2 * t_f$ equal to 13.8. There are two likely sources for the observed damage: either the bridge was subjected to an excessively overweight vehicle at some time during its service life or the damage was caused during pile driving and not noted in the bridges file. The flange local buckling was not noted by the state inspector, who assigned the substructure a condition rating of 6.

Figure 4.8 Evidence of Flange Local Buckling

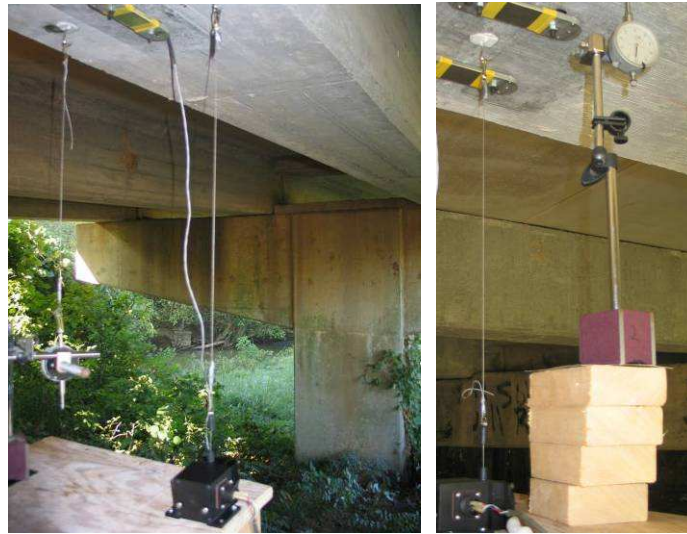
a stable platform and a cable was hung from the bottom of the girders down to the platform (Figure 4.11).

Figure 4.11 Gauge Mounting Chapter 3 Test (left), Chapter 4 Test (right)

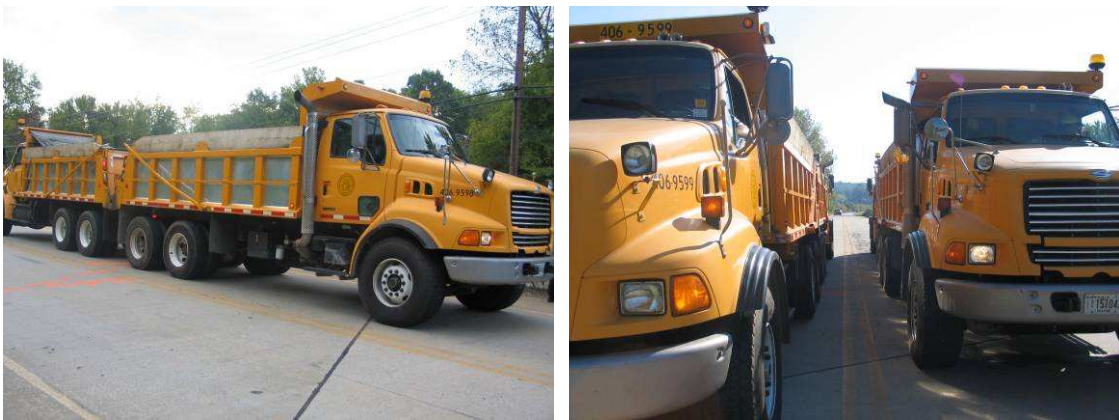
traffic. Several repetitions of each test were performed to establish reproducibility, with the bridge closed during each of the loading repetitions and reopened to traffic between repetitions to prevent traffic congestion. Each repetition began and ended with recording the reading from each gauge with no load on the test span; subsequently, the four trucks were backed onto the middle of the instrumented span, one truck at a time, starting with truck #1 and ending with #4 (Figure 4.12). Deflection measurements were then recorded from the DAC-pro instrumentation system and the mechanical dial gauges. Finally the trucks were moved off the test span and traffic was permitted to resume. Figure 4.13 illustrates two stages of the loading process.

Figure 4.13 2 Trucks (right), 4 Trucks (left)

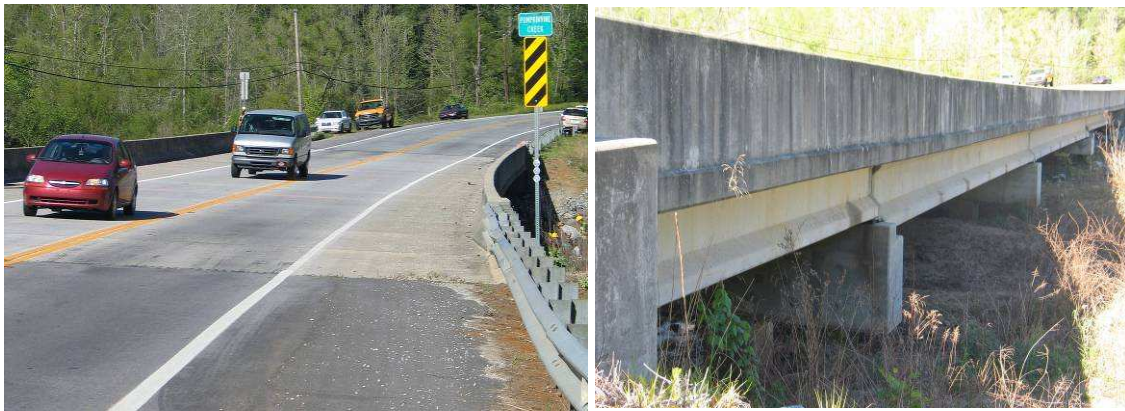
GDOT bridge ID # 223-0034-0 is located in Paulding County GA, and carries State Route 120 over Little Pumpkinvine Creek approximately 5 miles south of Dallas, GA. It was designed for HS-20 loading using the AASHTO 1989 specifications and was constructed in 1992. The main structural system consists of pre-stressed concrete I-girders arranged in four simply supported spans. Figure 5.1 shows an overview of the girder and bridge structure.

Figure 5.1 Bridge 223-0034-0 Overview

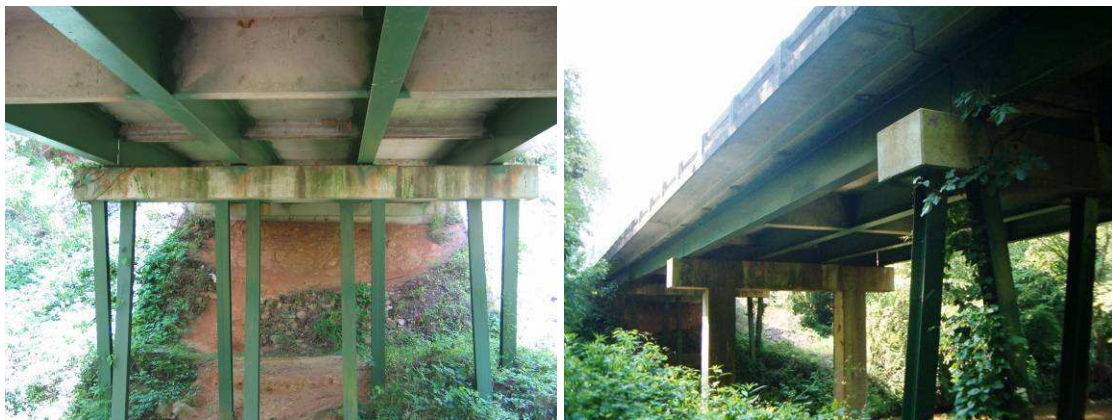
This bridge is located in Dawson County GA (GDOT ID# 085-0018-0), and carries State Route 136 over the Etowah River approximately 5.7 miles east of Dawsonville. The bridge has four simply supported spans. Figure 6.1 shows an overview of the bridge, girders and supporting substructure. An elevation is shown in Figure 6.2. The bridge is posted, as described subsequently.

Figure 6.1 Bridge 085-0018-0 Overview

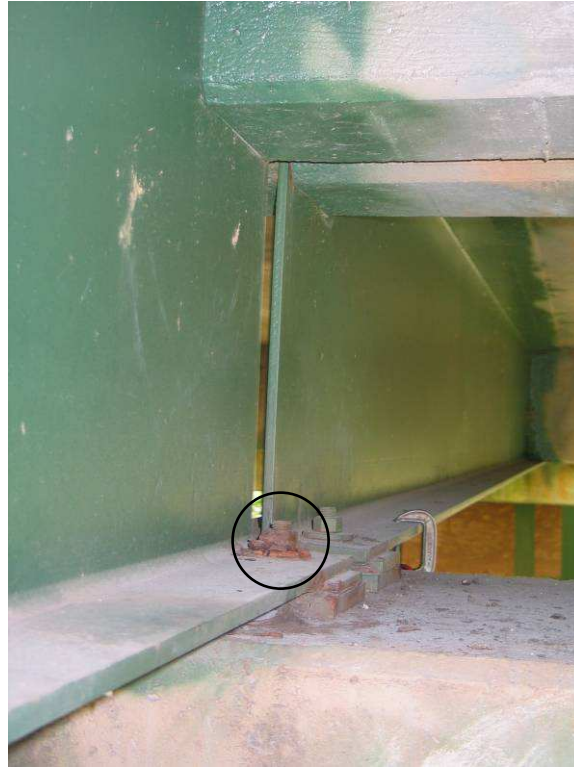
flanges. On the other hand, it was noted that several anchor bolts were severely corroded, including the bolt that was found to be fractured by the GDOT inspector (Figure 6.6). The GDOT inspector also gave the substructure an assessment rating of 6.

Figure 6.6 Corrosion and Fracture of Anchor Bolt

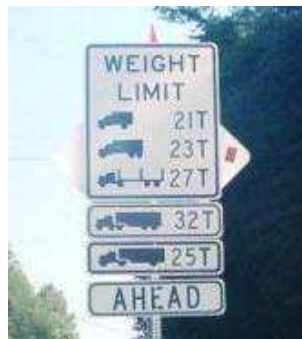
All condition assessment ratings were determined at the time of the latest inspection on June 30, 2005. Based on that inspection, the GDOT engineer determined that the bridge required posting for 5 of the 6 legal loads. The resulting postings restrict H type trucks to a maximum of 21 tons, Tandem trucks to 23 tons, Logging trucks to 27 tons, 3-S-2 type trucks to 32 tons, and HS type trucks to 25 tons (Figure 6.7).

Figure 6.7 Posting Sign for Bridge 085-0018-0

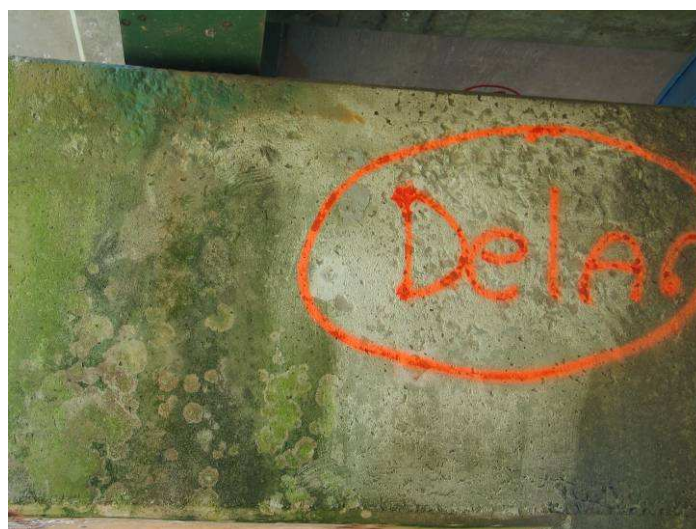
Figure 6.13 Delamination of Concrete Pier Cap
